POLYGON SENSORS MONITOR WOOD MOISTURE CONTENT ON TRUEBECK'S MASS TIMBER PROJECT

CASE STUDY: TIMBERVIEW VIII

MOISTURE MITIGATION FOR MASS TIMBER IN AFFORDABLE HOUSING PROJECT

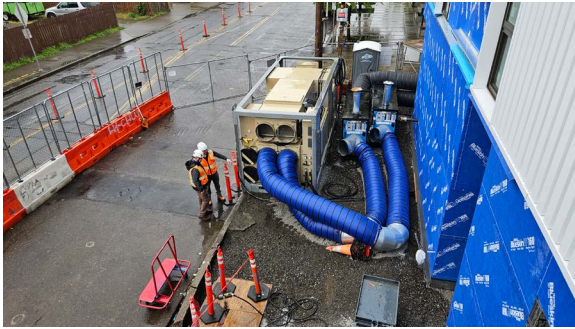
POLYGON CLIMATE CONTROL EQUIPMENT (DESICCANT DEHUMIDIFIER AND INDIRECT FIRED HEATERS) TREAT INTERIOR CONDITIONS OF TIMBERVIEW VIII

6,575 degrees Fahrenheit and 45 percent to 55 percent relative humidity (RH). Twenty sensors measured and alerted on ambient T/RH with continuous readings of wood moisture content. Data was used to automatically turn on and off a desiccant dehumidifier and indirect fired heaters to optimize drying and heat with the least energy consumed.
